## **ROUNDS GREEN NEW COLLIERY DISASTER, 1846**

## **Rounds Green New Colliery Accident Report 1847**

### Report from Geological Survey Office, 19th January 1847

#### by Warington W Smyth

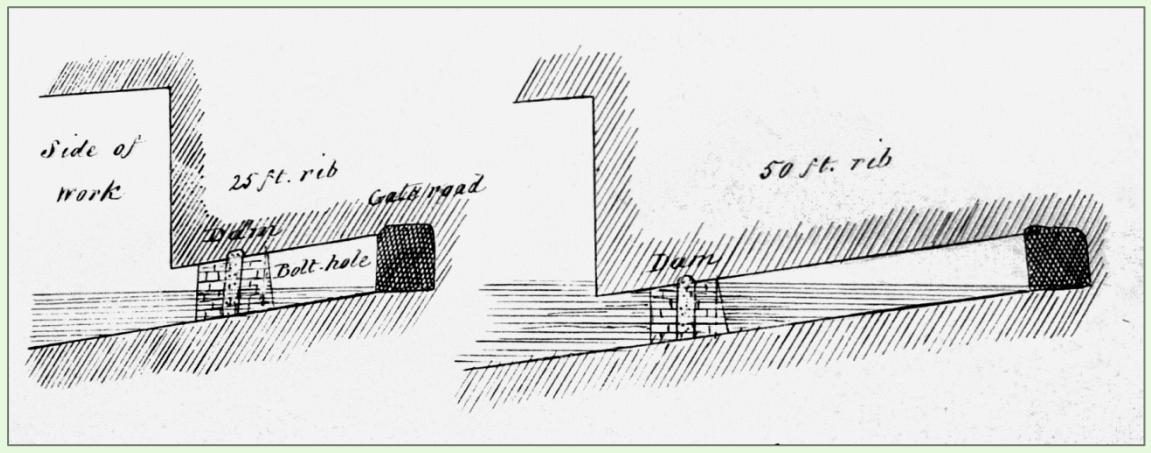
On the dip side of the gate road, between the shafts and the present workings, are five abandoned sides of work, the entrances to which are thus dammed. The drainage water out of the mine will naturally fill these to the level of the gate road, and where the dip of the seam is great and the rib of considerable thickness, the bolt hole being generally from 7 to 10 feet in height, the water will effectually close the entrance, but where the rib is of smaller dimensions, a fault in the dam, by leaving the passage for gaseous fluids, may leads to serious consequences.

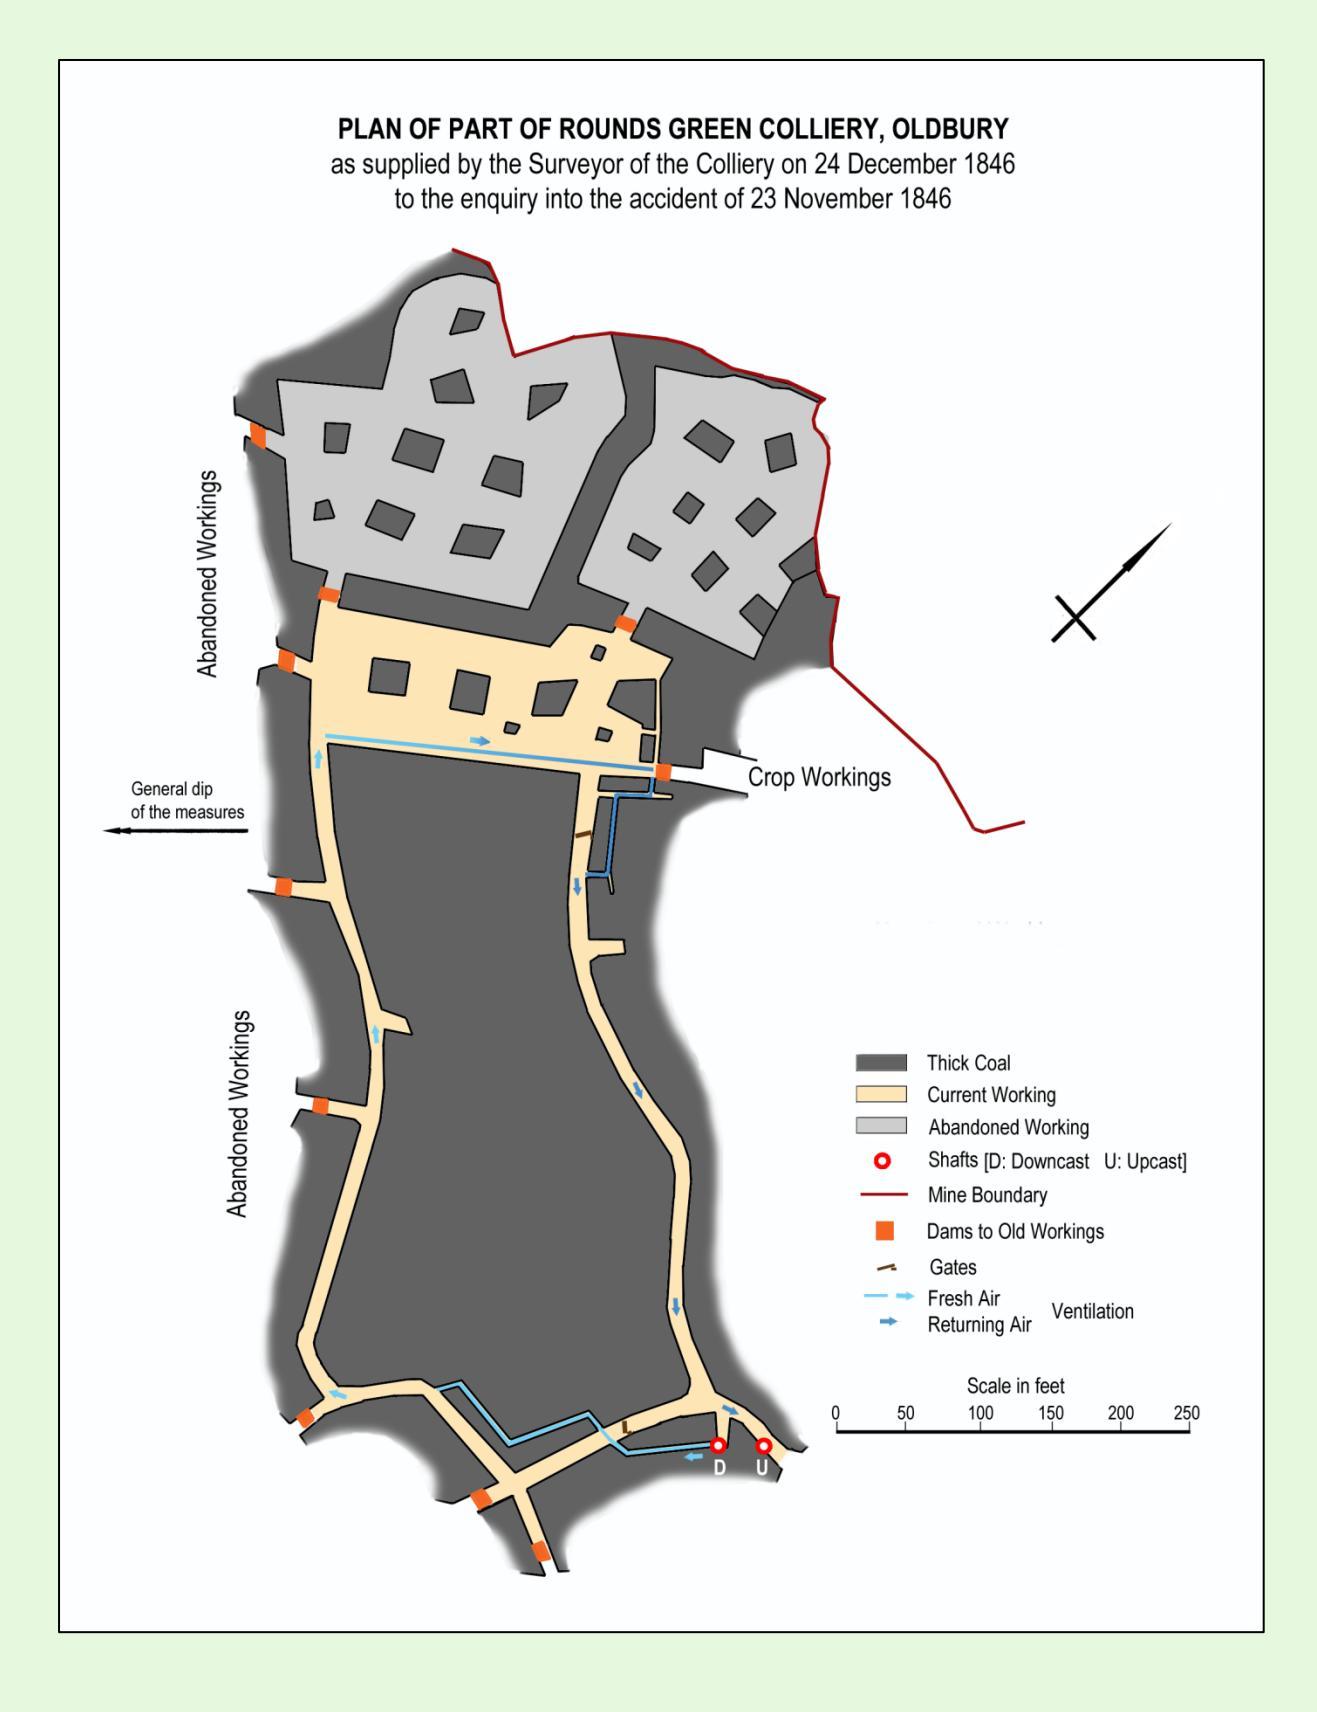
Little attention appears to be paid to the point at which the air heading from the downcast shaft opens into the gate road. It will be apparent, on inspection of the accompanying plan, that so soon as an explosion occurs, strong enough only to blow down the door in the gate road, the fresh air will at once pass round to the upcast shaft, and that in the workings being left in a state of stagnation, all the men who survived the explosion must necessarily perish; and it is well known that on occasions of this kind, the minor part only of the sufferers are killed by the actual combustion of the fire damp. If the airway was, on the contrary, carried independently to the sides of work, it is manifest that as long as any current is in circulation fresh air will be supplied to the spot where, on the present system, many might be dying for want of it.

Where a pair of shafts are of equal depth, a Colliery cannot be said the be safely ventilated, unless the column of warm air in the upcast shaft be lengthened by a tower, or chimney, built over the mouth, or the current determined and increased by the aid of a furnace or by machinery for supplying fresh or exhausting return air.
